Manhole Inspection Summary

Manhole # S51CC_016MH

Insp Date: **2/20/08 1:00 PM**

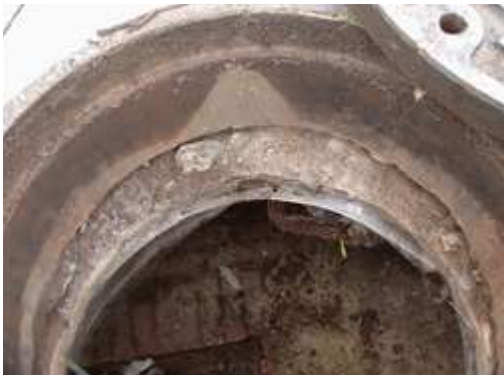
Defect 1

Offset: **4** (in.)

Offset

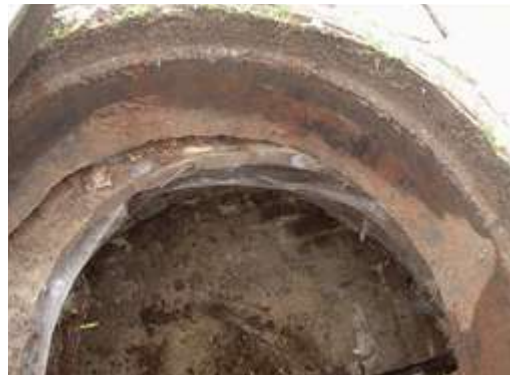
Defect 2

☒ **Leaks**

Frame Leaks

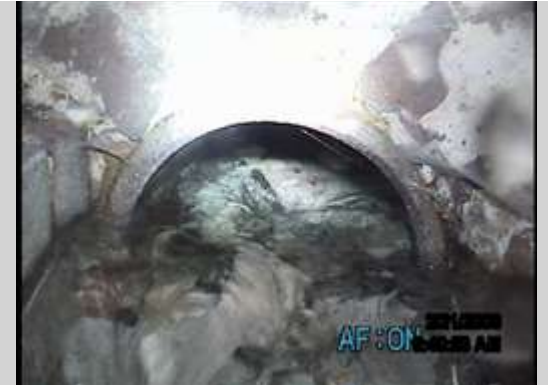
8 in. Circular Gravity Sewer
Pipe Out @ 12 O'Clock

12 O'Clock Outflow

Pipe Height: **8.4** (in.) Rod and Bar (Angled)
Pipe Material: **Clay** ☐ Pipe Lined
Invert Depth: **5.00** (ft.) Flow Characteristics: **Fast**
Deposits: ☐ None ☐ Mud ☐ Sludge ☒ **Debris** ☐ Grease
Silt Depth: **2** (in.) Deposits Extent: **Medium**
Infiltration: **None** Pipe Seal Cond: **Sound**

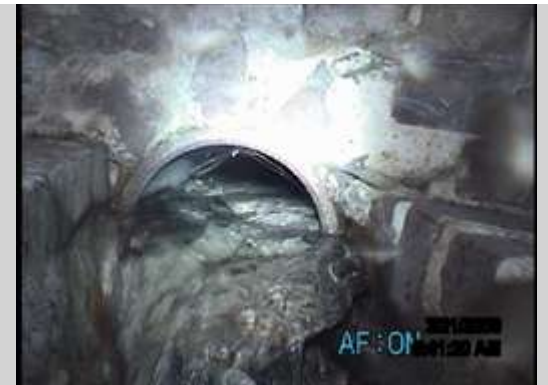
8 in. Circular Gravity Sewer
Pipe In @ 9 O'Clock

9 O'Clock Inflow

Pipe Height: **8.4** (in.) Rod and Bar (Angled)
Pipe Material: **Clay** ☐ Pipe Lined
Invert Depth: **4.70** (ft.) Flow Characteristics: **Fast**
Deposits: ☐ None ☐ Mud ☐ Sludge ☒ **Debris** ☐ Grease
Silt Depth: **5** (in.) Deposits Extent: **Heavy**
Infiltration: **None** Pipe Seal Cond: **Sound**
